Subject: Clock Shows Dashes and Cannot be Set After Battery Disconnect

This bulletin replaces PIT5652E. Please discard all copies of PIT5652.

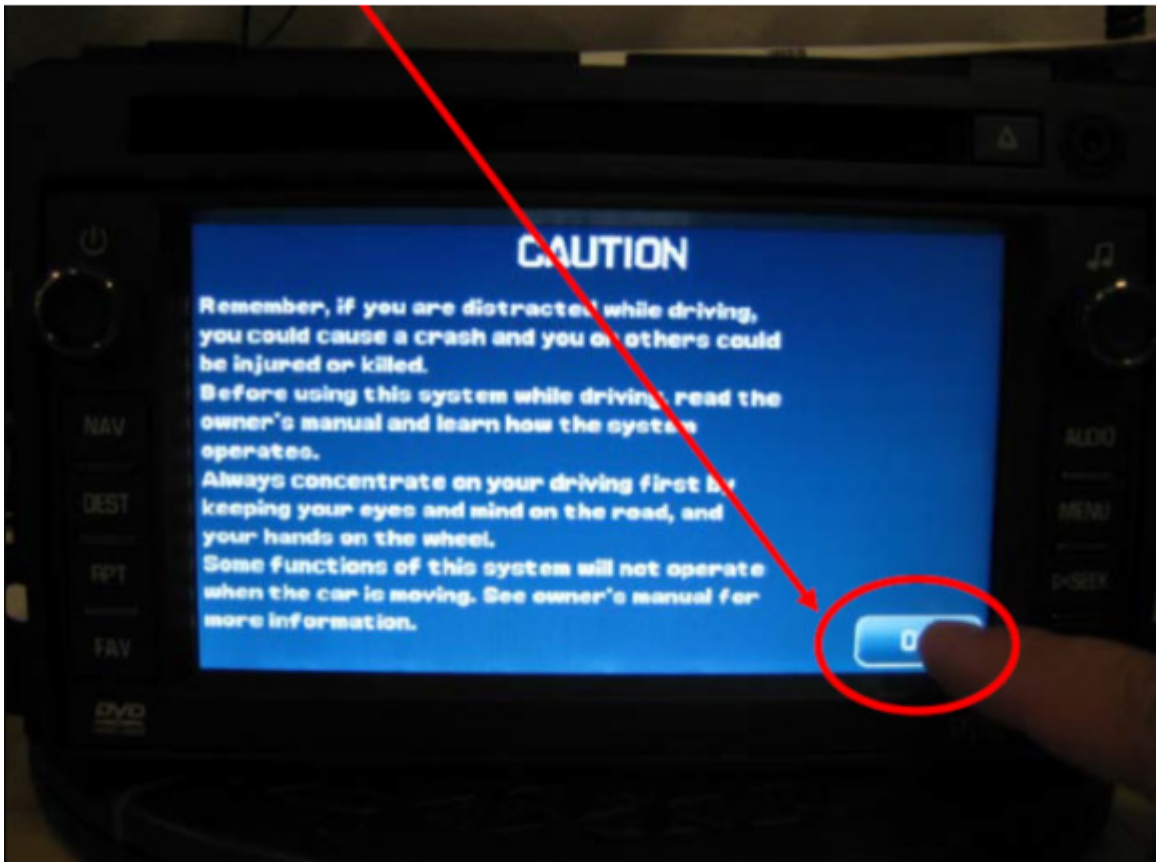
5440780

1. Turn the vehicle and radio on.
2. If the "CAUTION" screen is displayed, press "OK."

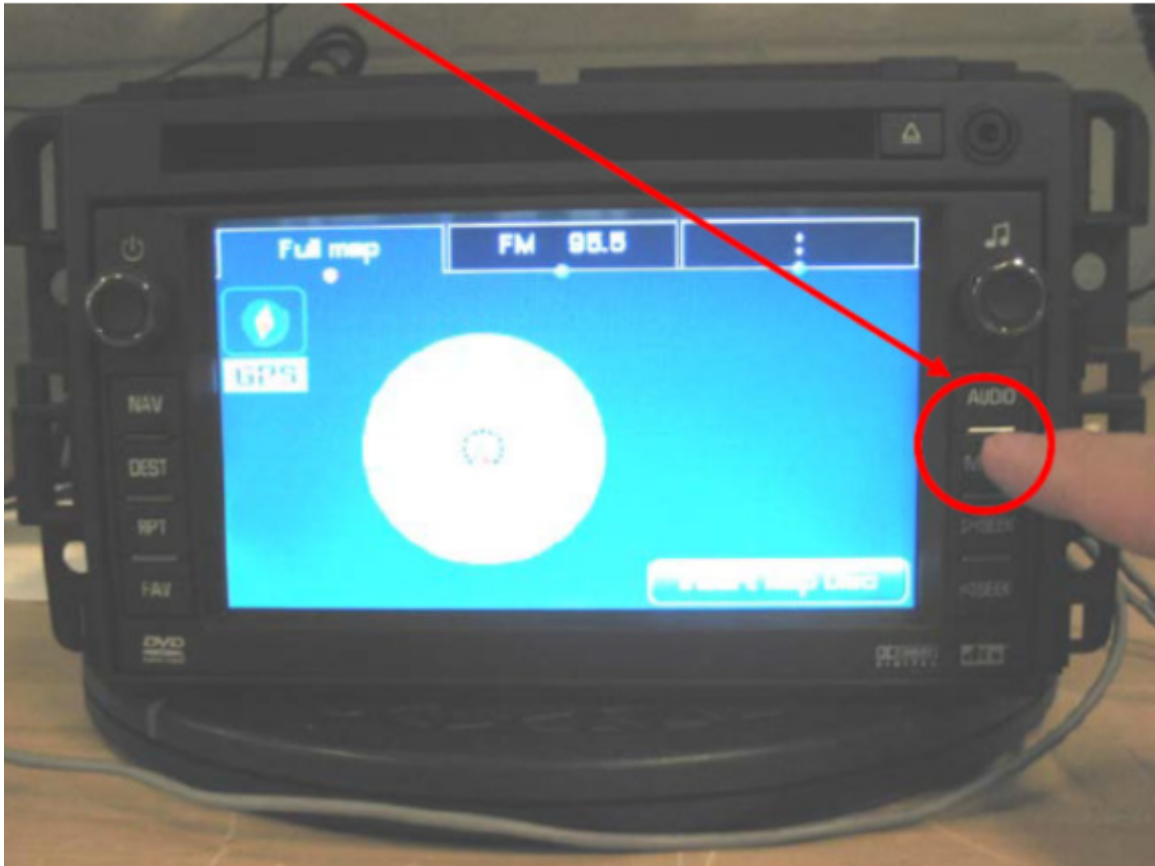
5440779

3. Press the hard "Menu" button on the right side of the radio.

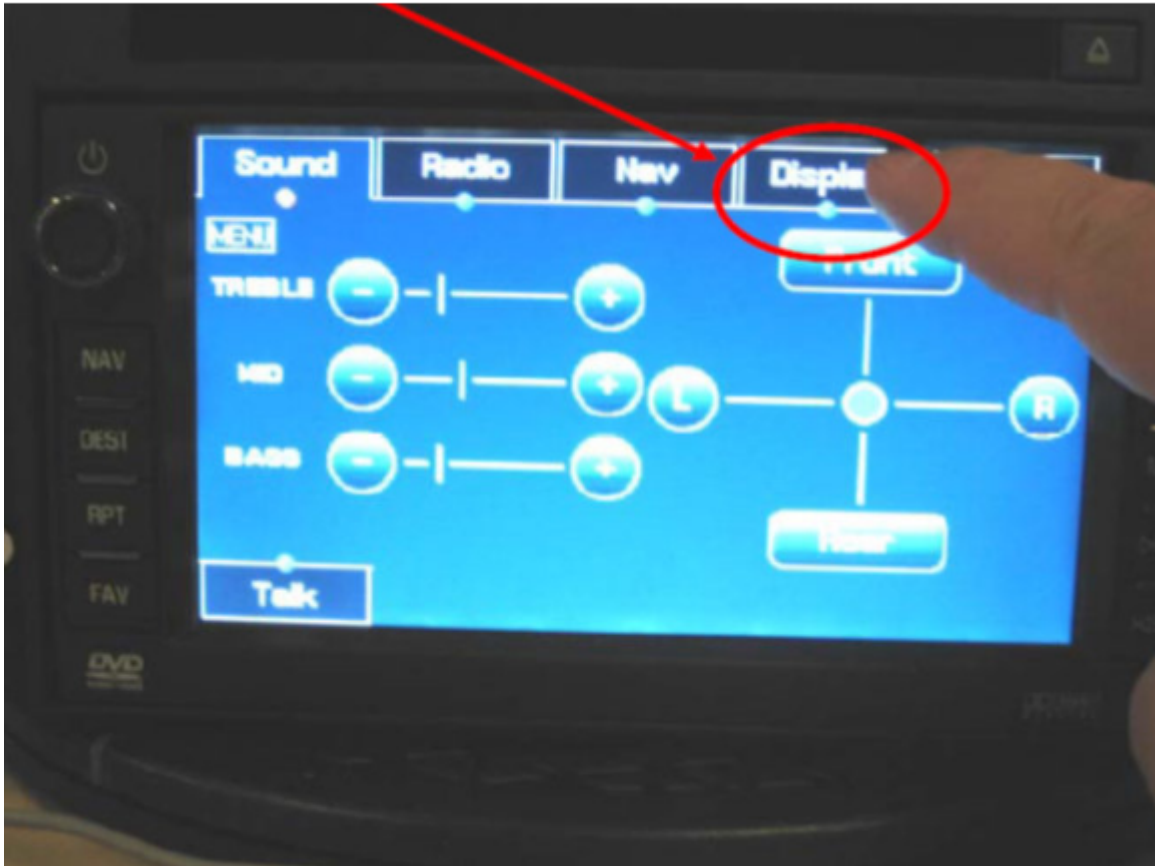
5440777

4. At the top of the display, press the "Display" soft key.

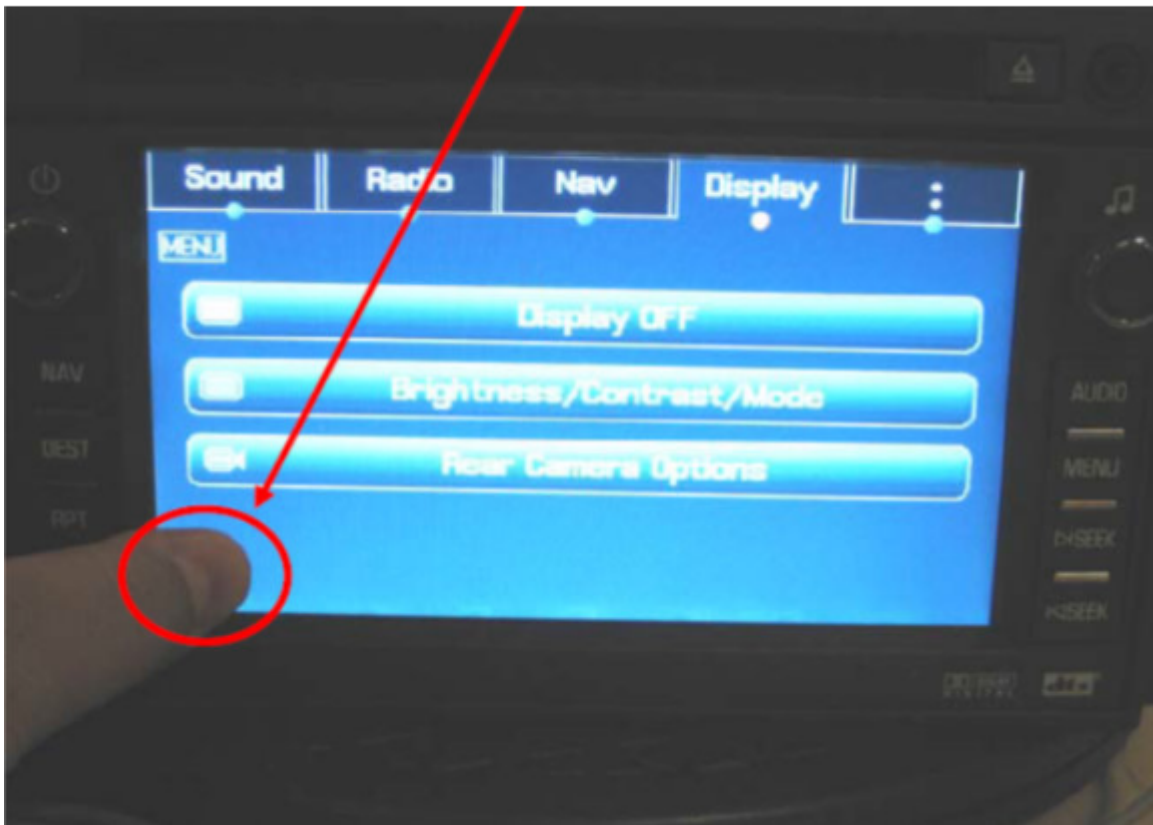
5440774

5. In the lower left of the next screen, press and hold in the lower left of the screen for 5–10 seconds (there will not be a button shown, the button is hidden).

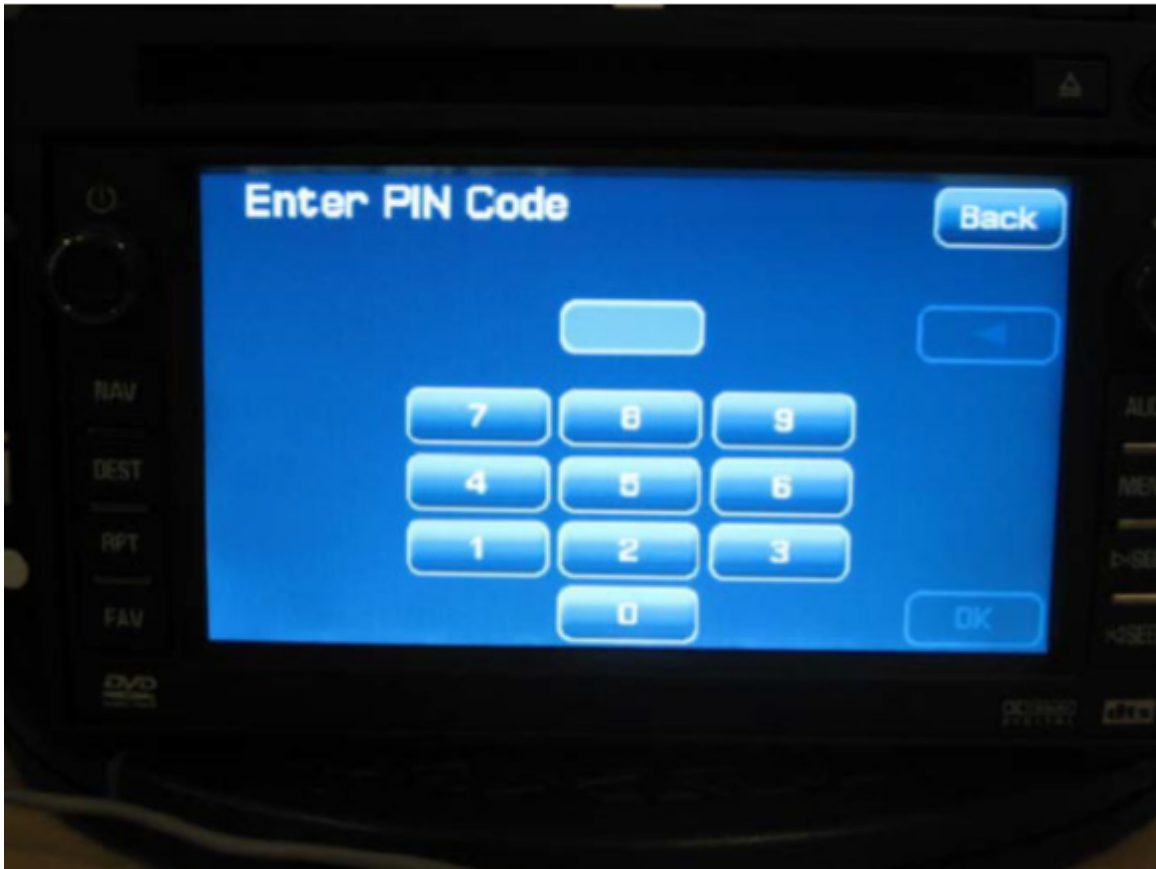
5440762

6. When the screen to Enter PIN Code appears, enter "660" (Other codes that may work if the next page icon is missing are 295660, 3657, 9448, 1791, 1765, 1756, 3366, 296645).

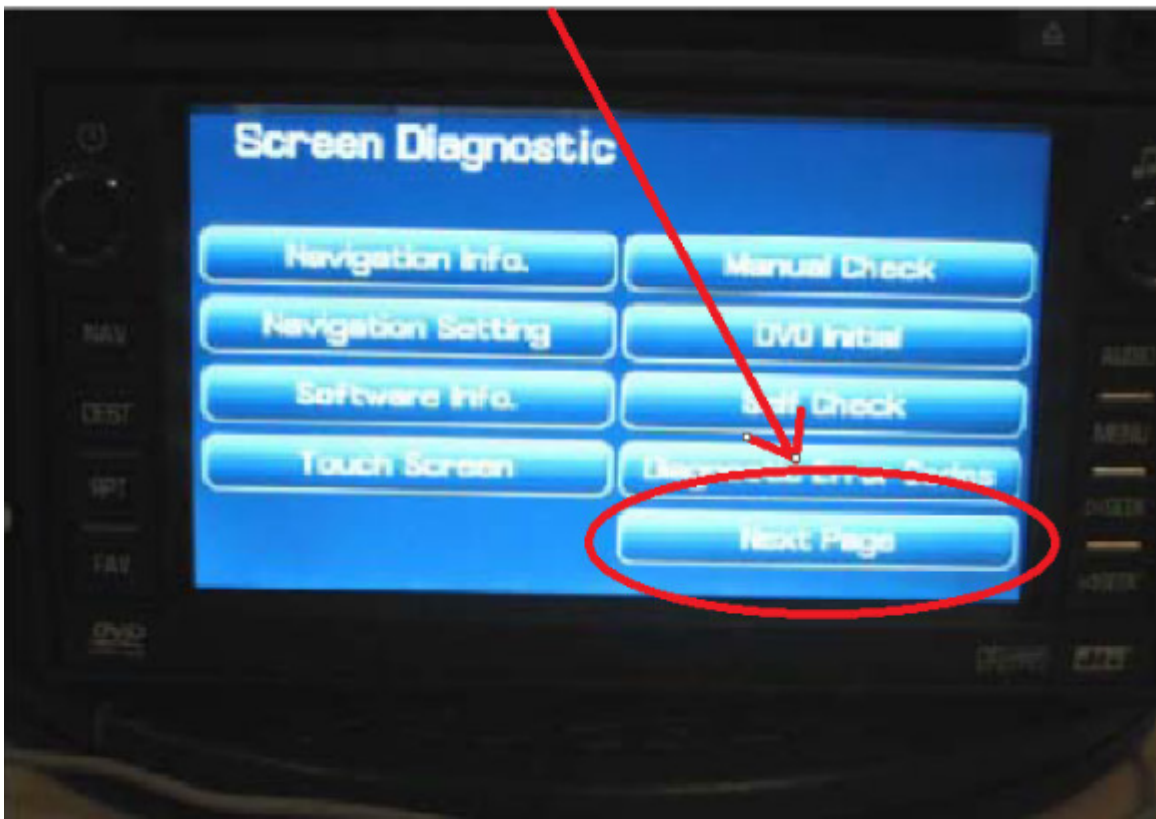
5440775

7. Select "Next Page" from the "Screen Diagnostic" page.

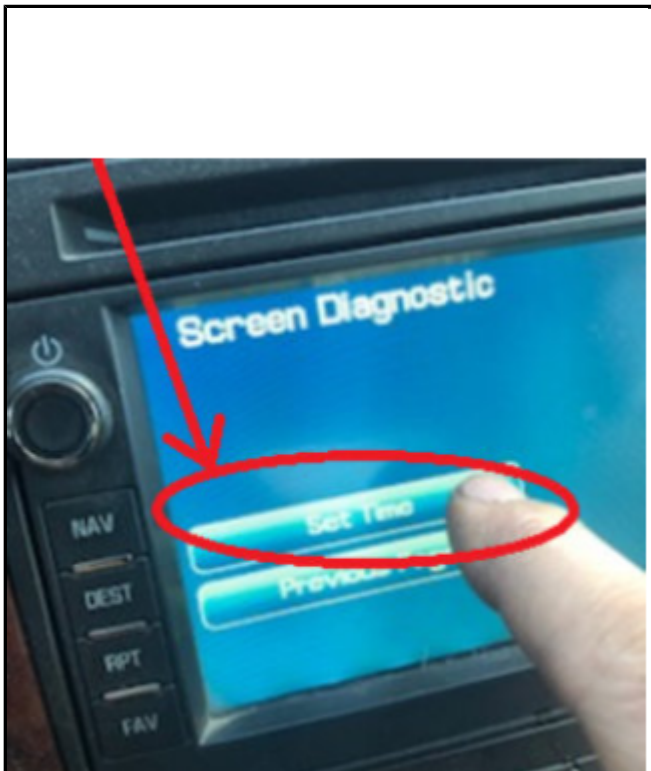
5440781

8. Select "Set Time."

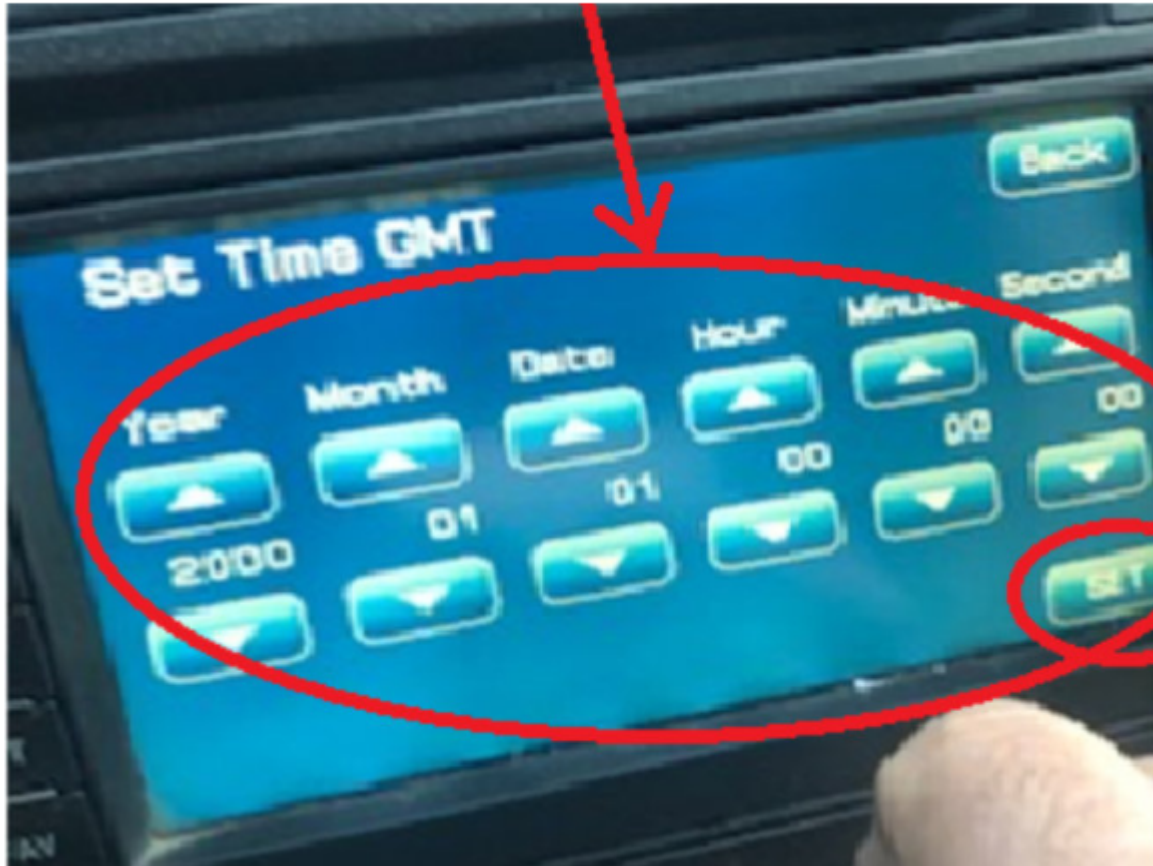
5440764

9. Enter the current date and time, then select "Set" from the lower right of display.

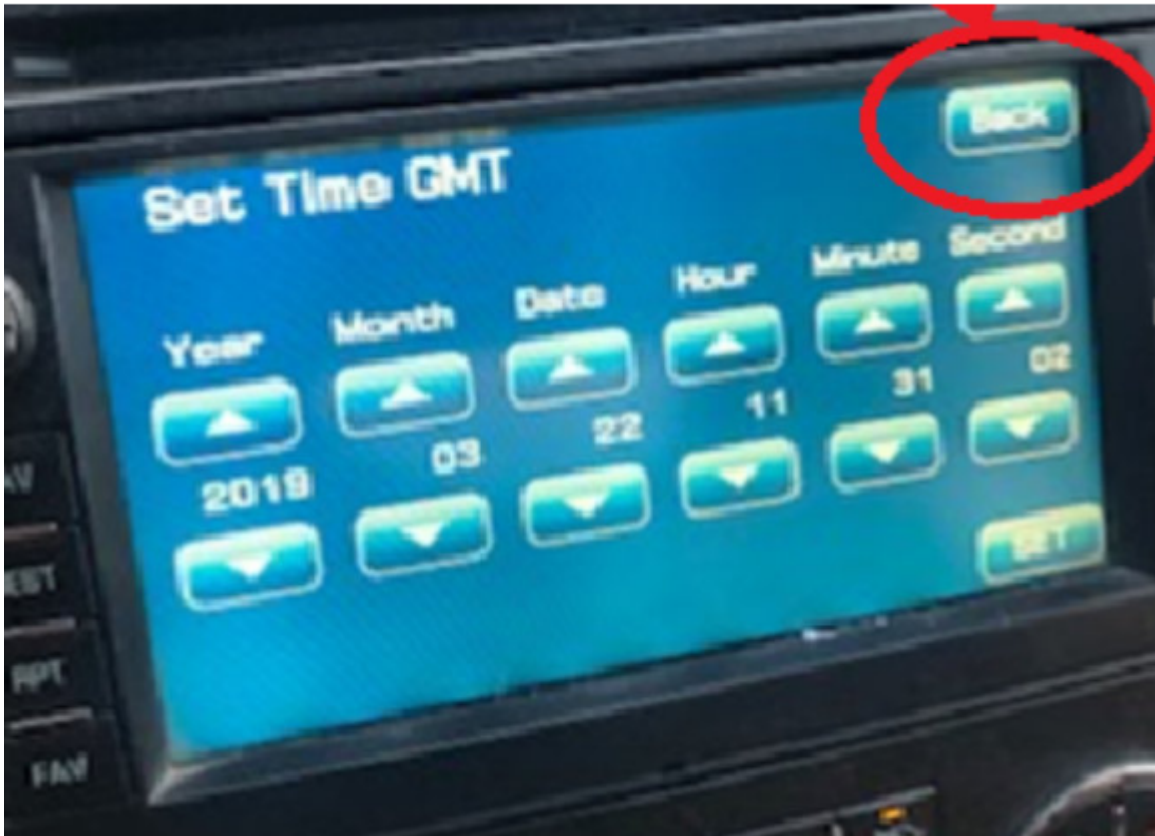
5440776

10. Press "Back" to return to the previous screen.

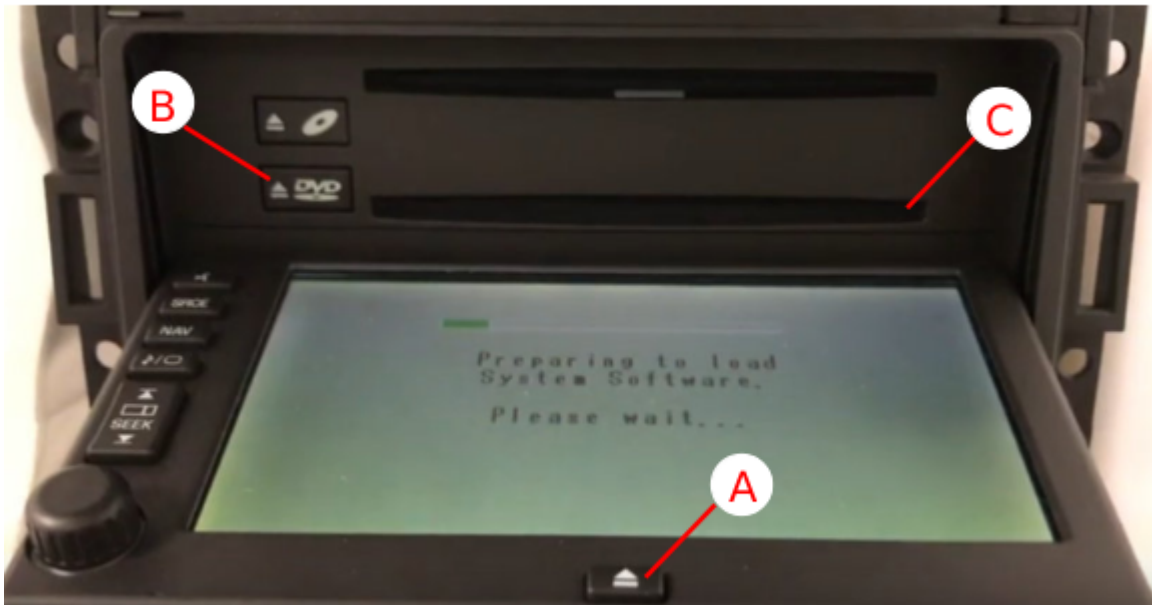
5440759

6. The update will start automatically. You will see a progress bar on the screen. The update takes about 2 minutes. The vehicle logo will be seen once the update is completed.

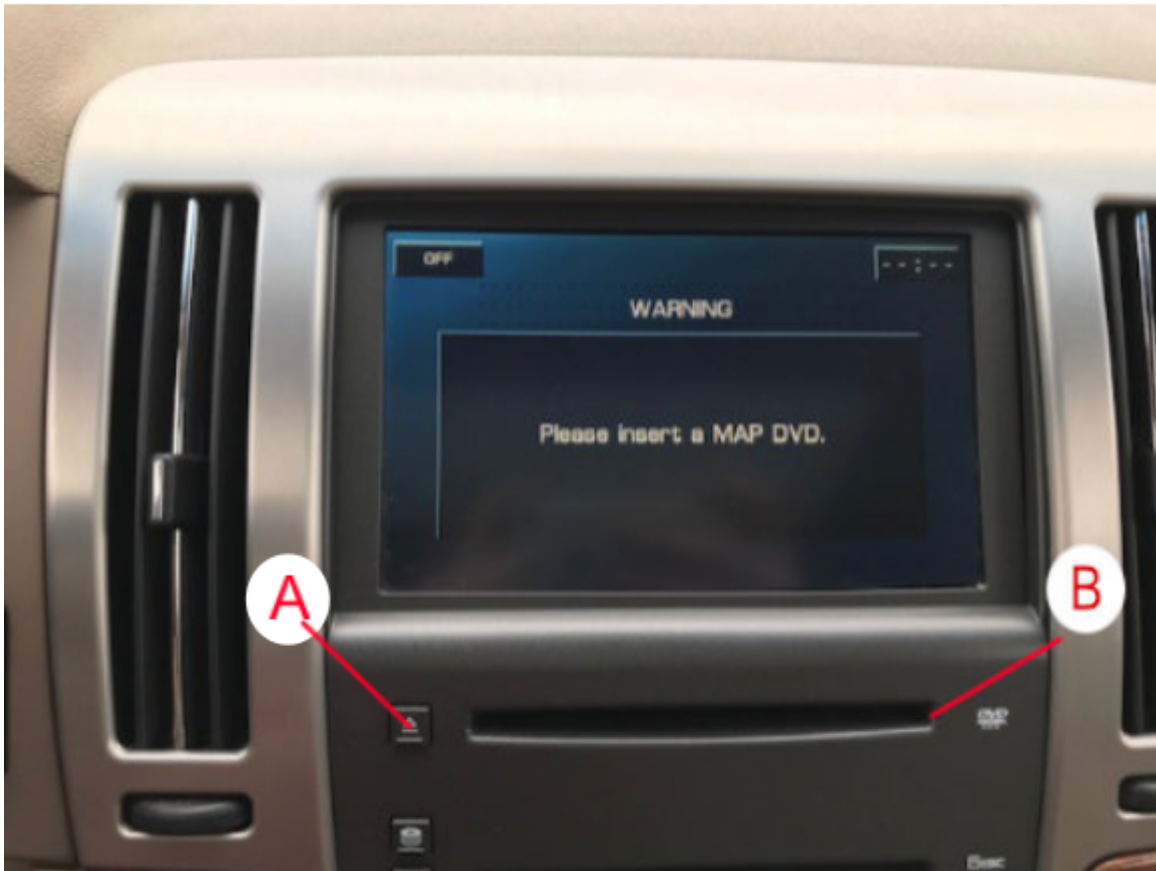
5440769

- Root
 - —> LOADING.KWI
3. Make sure the vehicle is outside and the engine is running.
4. Eject the map disc by pressing DVD Map Database Eject Key (A). Insert the Software Update Disc in the DVD Map Database Slot (B).

6. Eject the update disc and insert the map disc into the DVD Map Database Slot.
