#08-01-39-004: Rattle Noise From Right Front Area of Engine Compartment (Reposition A/C Line Away From Frame Rail) - (May 9, 2008)

Models: 2008 Saturn Astra

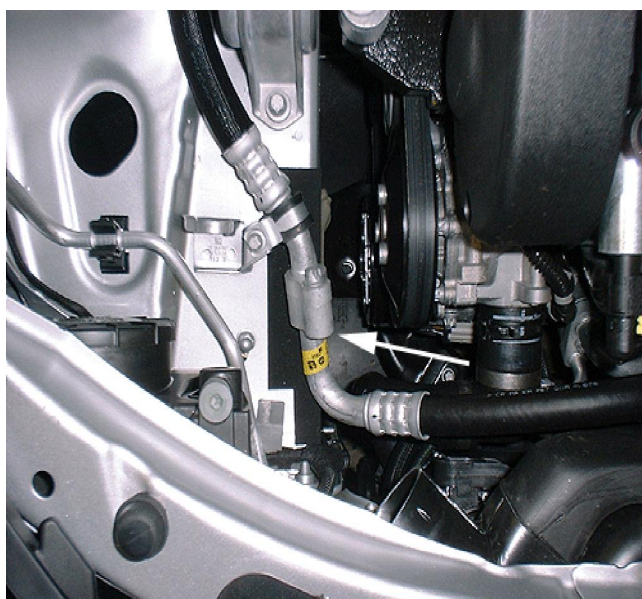
The low side Air Conditioning (A/C) line may contact the right front frame rail just below the air cleaner assembly.

Refer to the illustration above, which shows the location of the A/C line contact point on the frame rail.

Technicians are to reposition the A/C line to provide sufficient clearance away from the frame rail.
© 2019 General Motors Corporation. All rights reserved.
